# MEMORANDUM

Date: April 28, 2015  
To: Board of Education  
From: Tim Buresh  
Regarding: BHUSD CAPITAL IMPROVEMENTS PROGRAM  
Subject: AUDITORIUM CLOSURE AND BUILDING RISK

## **The Temporary Auditorium Closure and Building Risk**

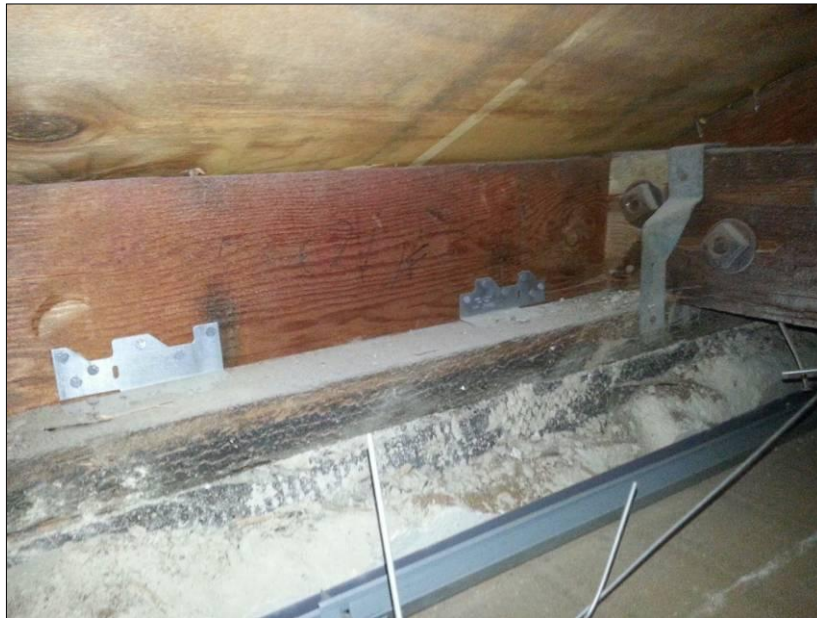
***Picture 1 – Top of Wall to Roof Condition in Classroom Ceiling Plenum – Building B (showing Simpson A35 retrofit, ply'd shtg, lack of OOP anch's)***

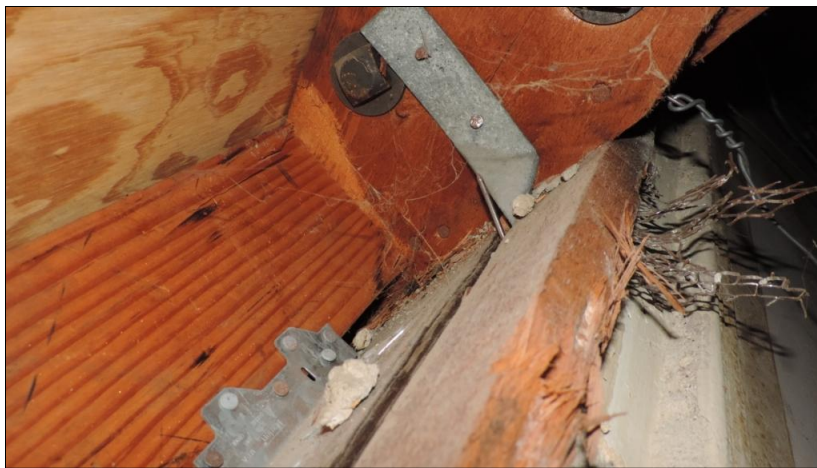
***Picture 2 – Top of Wall to Roof Condition in Classroom Ceiling Plenum – Building B (showing Simpson A35 retrofit, ply'd shtg, lack of OOP anch's)***

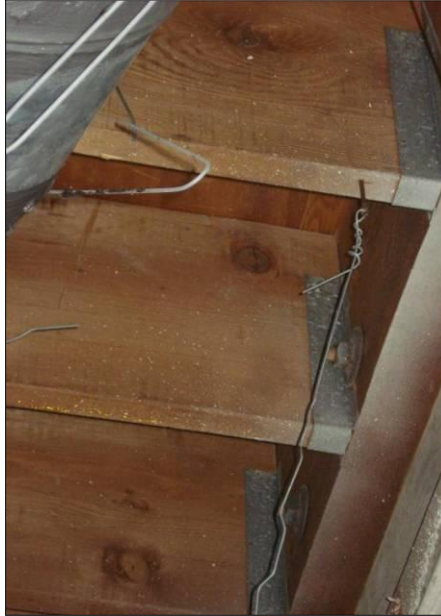
**Picture 3 – Wall to Floor Condition in Classroom Ceiling Plenum – Building C**  
(showing lack of OOP anch' s)

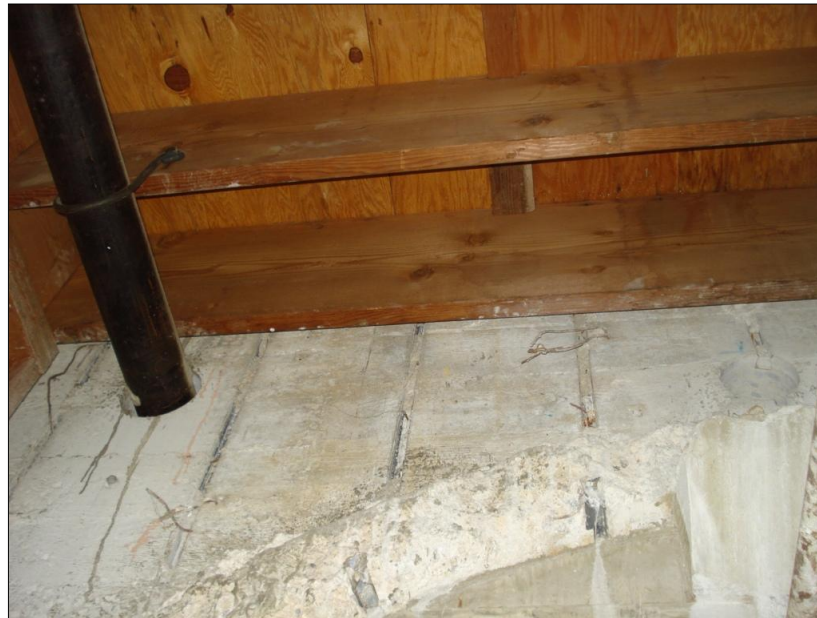
**Picture 4 – Building C (conc. wall) to Building D (wood framing) Condition at in Hallway Ceiling Plenum – 1<sup>st</sup> Floor**  
(showing seismic separation)

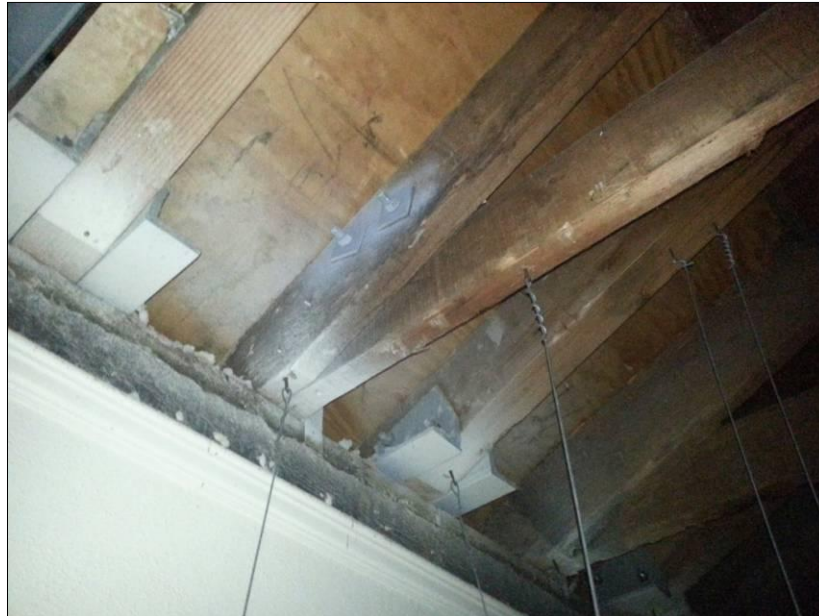
**Picture 5 – Roof to Top of Wall Condition – Building B**  
(showing angle and ply'd retrofit)

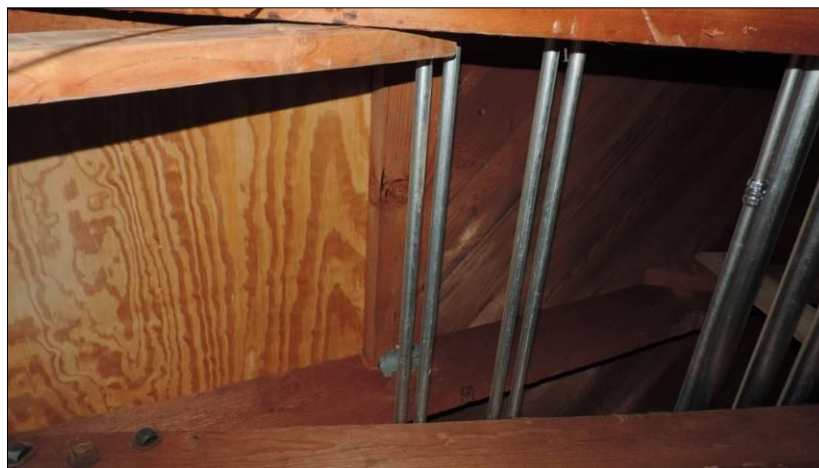
**Picture 6 – Roof Plywood Sheathing to Diagonal Sheathing Condition – Building B**  
(showing angle, ply'd, blocking retrofit)

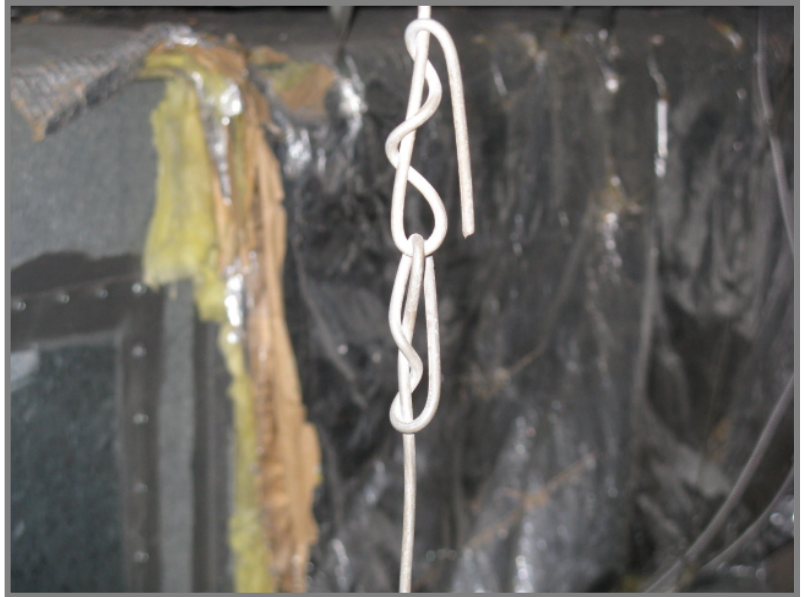
Photo 1  
Non-compliant ceiling wire

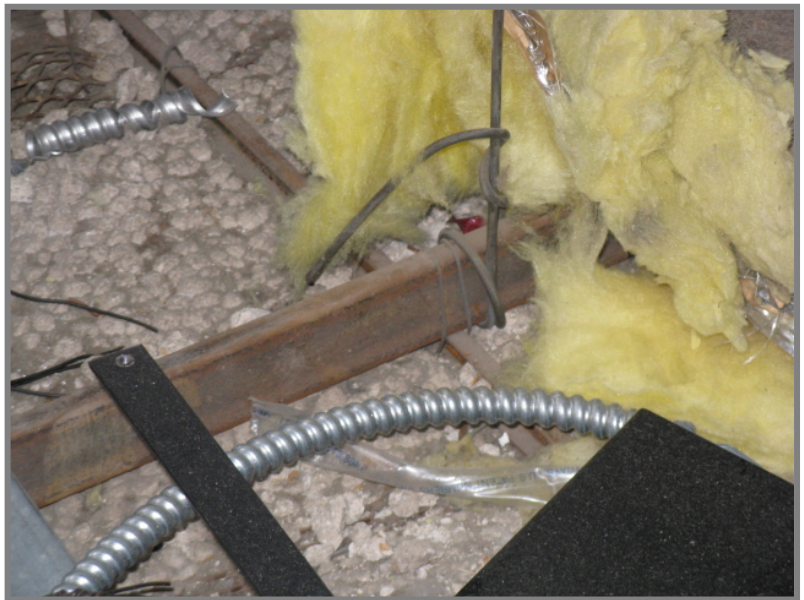
Photo 2  
Ceiling wire with inadequate number of turns (DSA requires 3 tight turns)

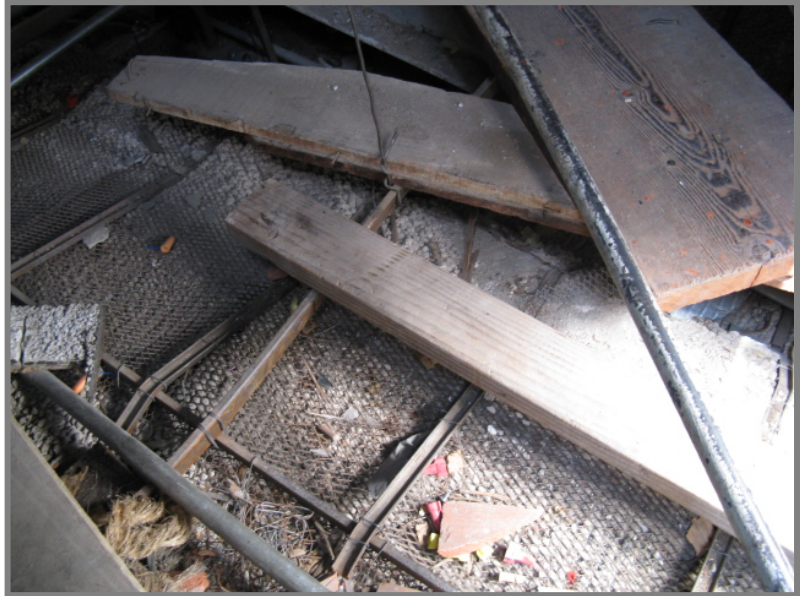
Photo 3  
Excess weight on ceiling caused by  
construction waste and debris

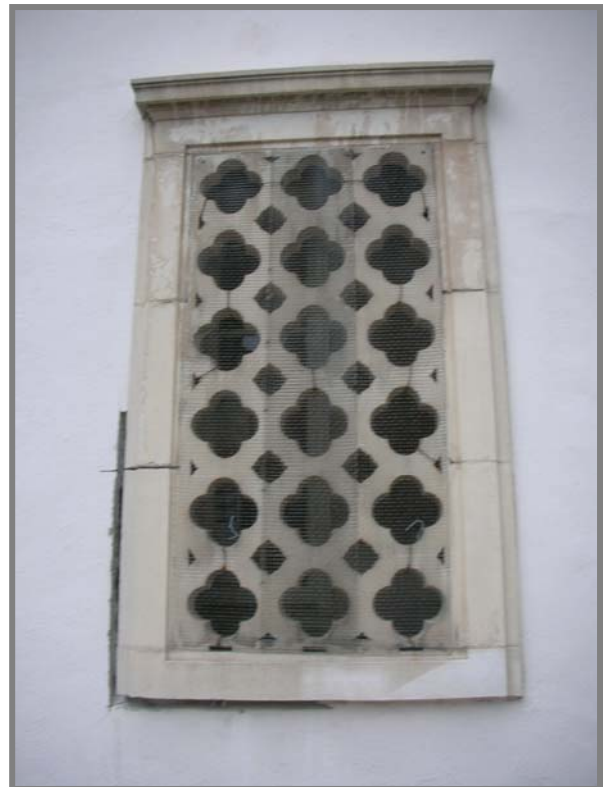
Photo 4  
Initial investigation of cast stone grill

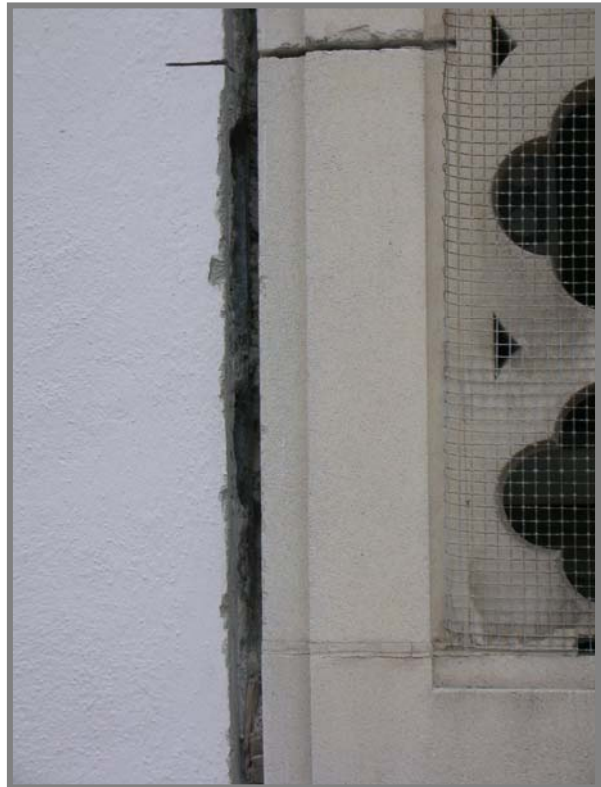
Photo 5  
Evidence of steel channel embed indicating possible  
anchor assembly (attached only to the concrete wall)

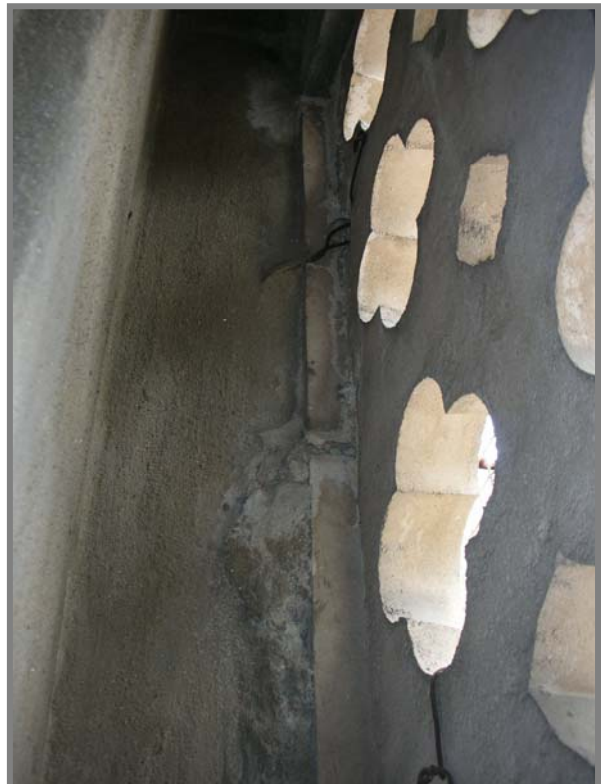
Photo 6  
Cast stone grill with wire tie embedded in mortar

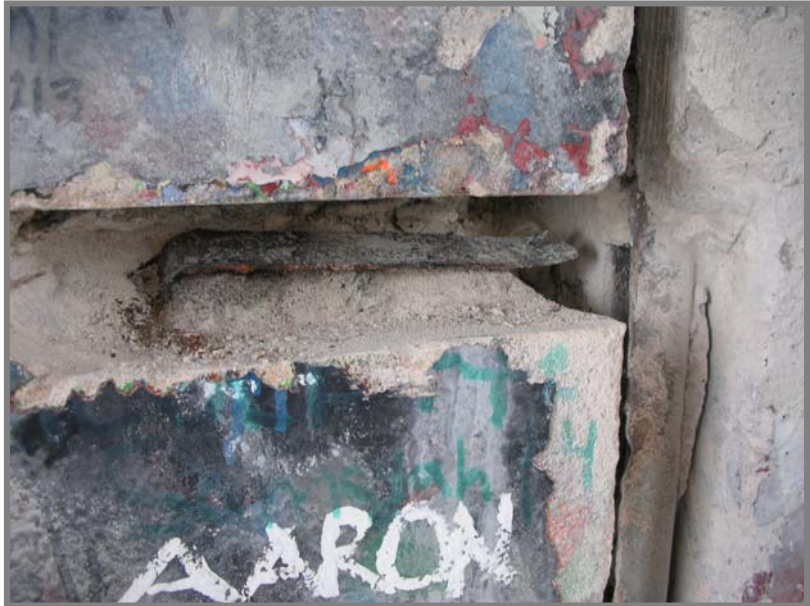
Photo 7  
Metal anchor found in mortar joint of  
cast stone, separated from metal  
channel embed

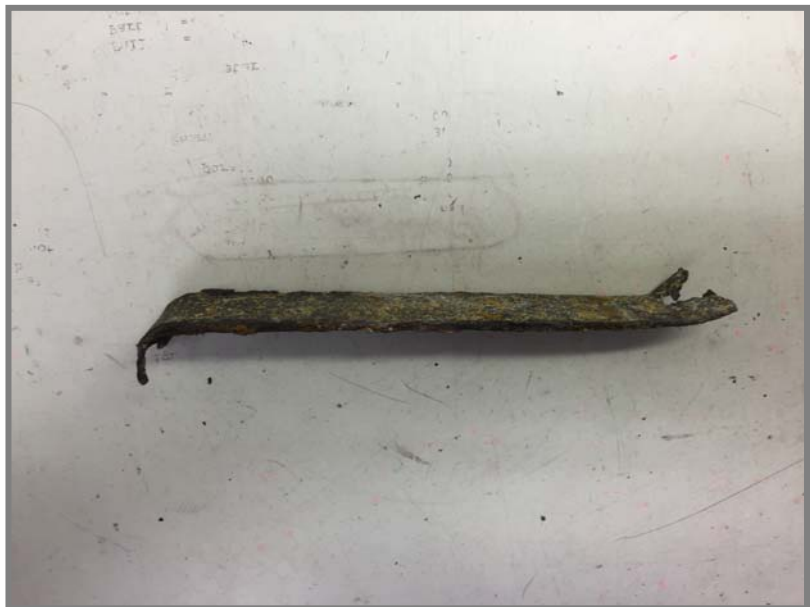
Photo 8  
Hooked metal anchor found in mortar  
joint of cast stone
