# MEMORANDUM

Date: April 28, 2015  
To: Board of Education  
From: Tim Buresh  
Regarding: BHUSD CAPITAL IMPROVEMENTS PROGRAM  
Subject: AUDITORIUM CLOSURE AND BUILDING RISK

## **The Temporary Auditorium Closure and Building Risk**

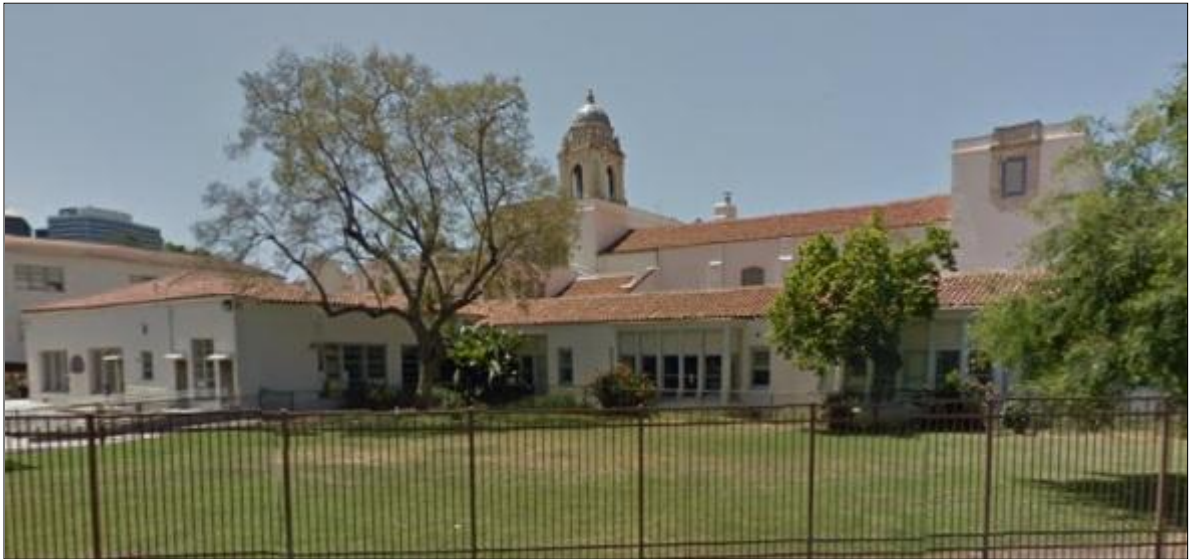
***Photograph 2 – Partial Eastern Elevation (looking South-West)**  
 Bldg B (low, foreground) and Bldg A (high, background)  
 Taken April 2013 (via GoogleMaps.com)*

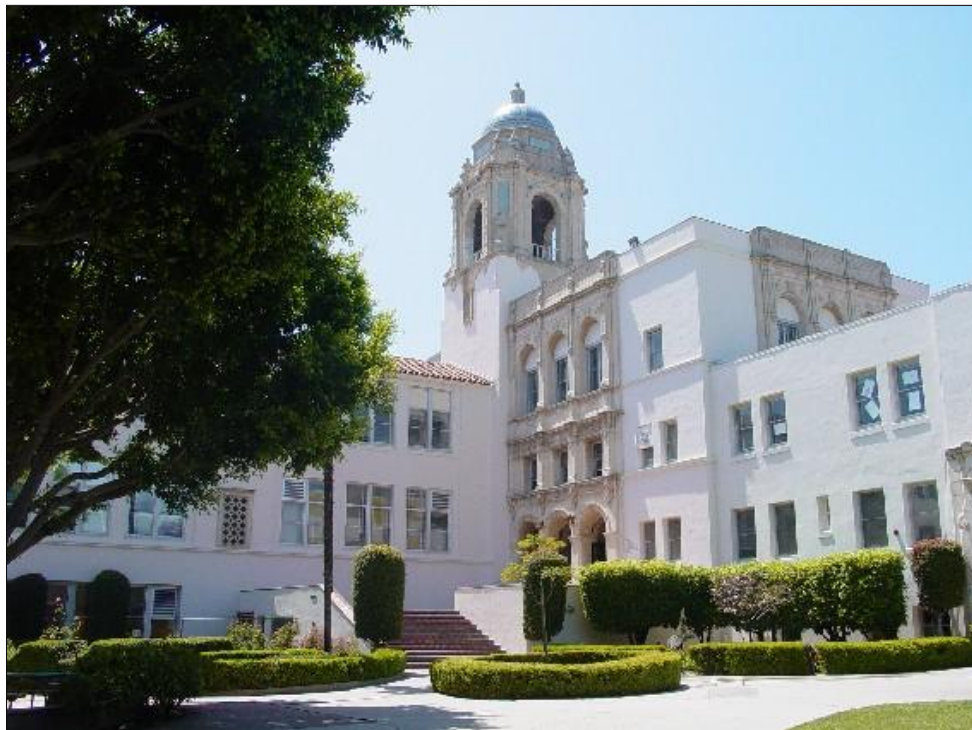
***Photograph 3 – Partial Eastern Elevation (looking North-West)**  
 Bldg C (left) and Bldg A-B (mid-to-right)  
 Taken 2002 (via Wikipedia.com)*

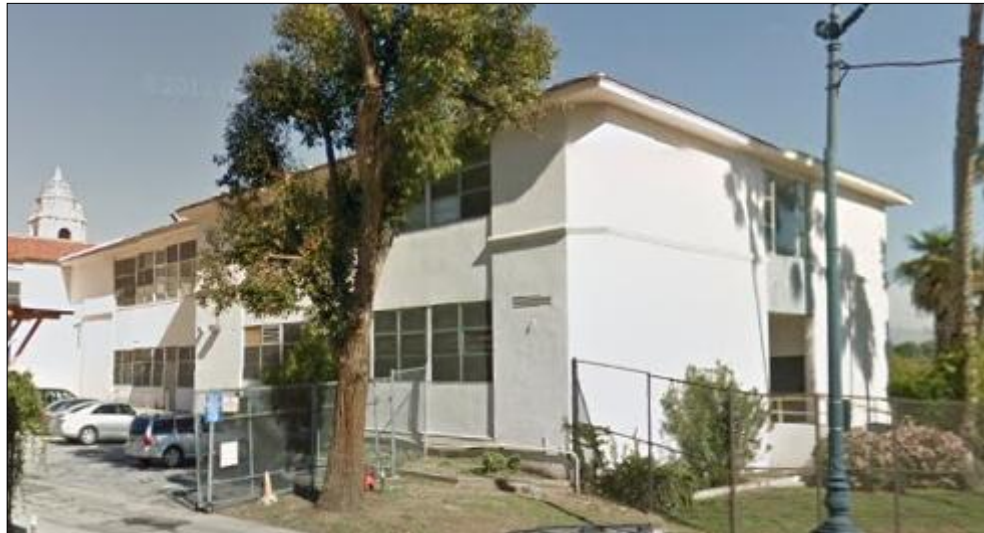
**Photograph 2 – Southern and Western Elevation (looking North-East)**  
*Bldg D (foreground) and Bldg C (left, background)*  
 Taken April 2013 (via GoogleMaps.com)

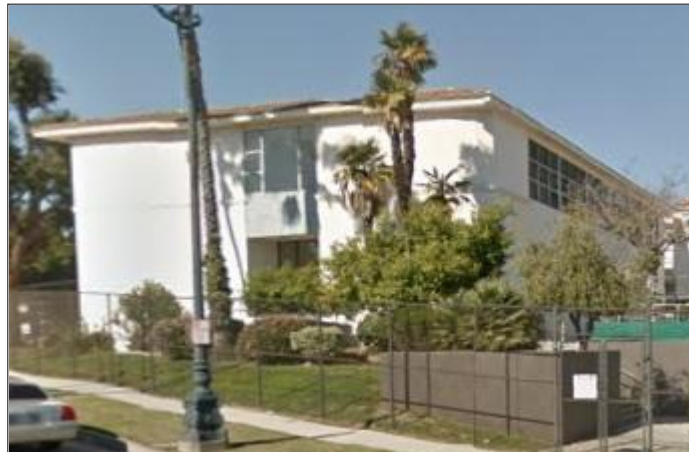
**Photograph 3 – Southern and Eastern Elevation (looking North-West)**  
 Building D; taken April 2013 (via GoogleMaps.com)

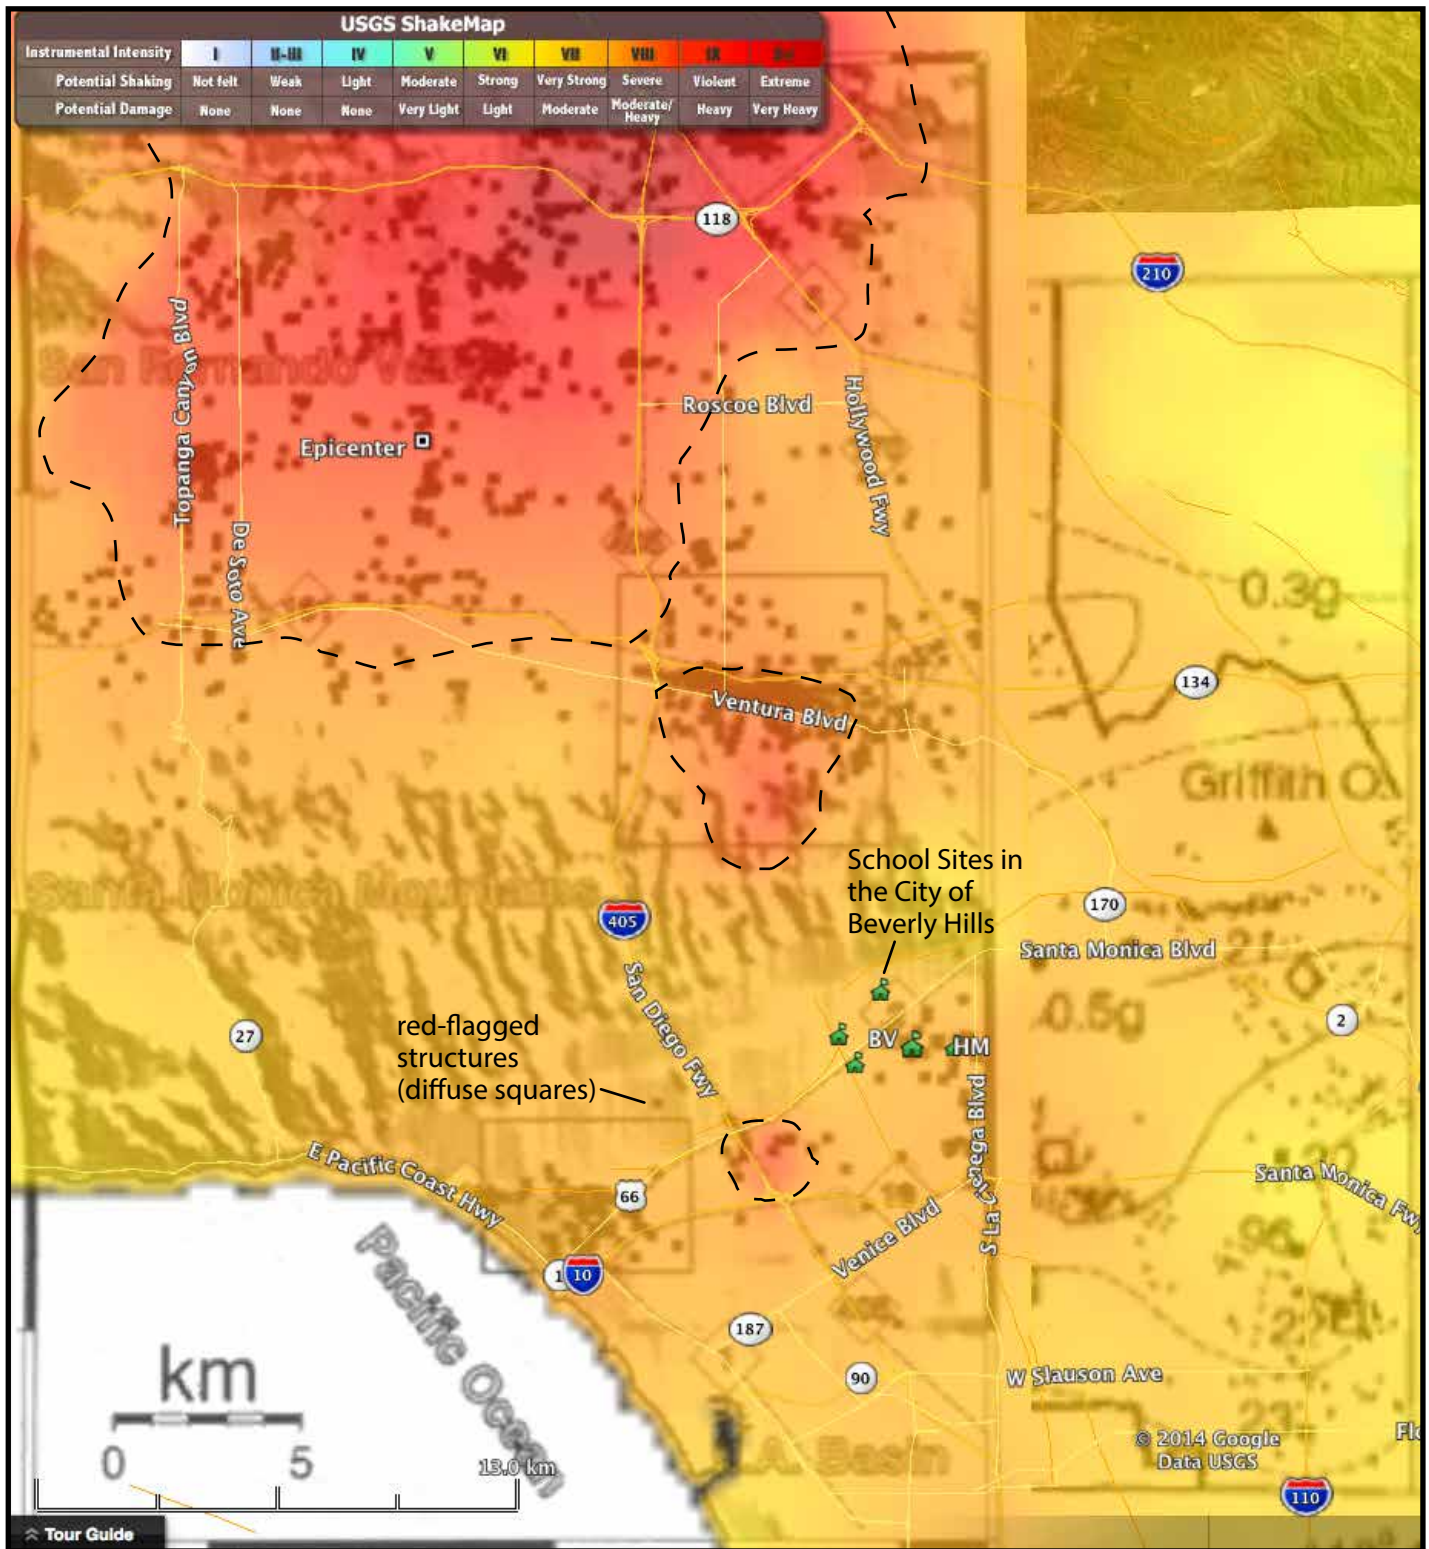
JN 723-11  
Date: JUNE, 2014  
Drafted by: MDK  
**PLATE 1**

A ground shaking intensity map provided by the USGS (website) for the 1994 Northridge earthquake indicates that the City of Beverly Hills was located in a region designated as very strong to lower severe (Plate 1). However, this region was not located in a region exhibiting the strongest ground motions during this earthquake, which are approximately outlined in Plate 1 by black dashed lines. Red-flagged structures identified after the earthquake are also shown on Plate 1.

Groundshaking intensity map from the USGS (website) associated with the 1994 Northridge Earthquake. Groundshaking USGS data overlies red-flagged structure data (■) of Trifunac and Todorovska (1997).

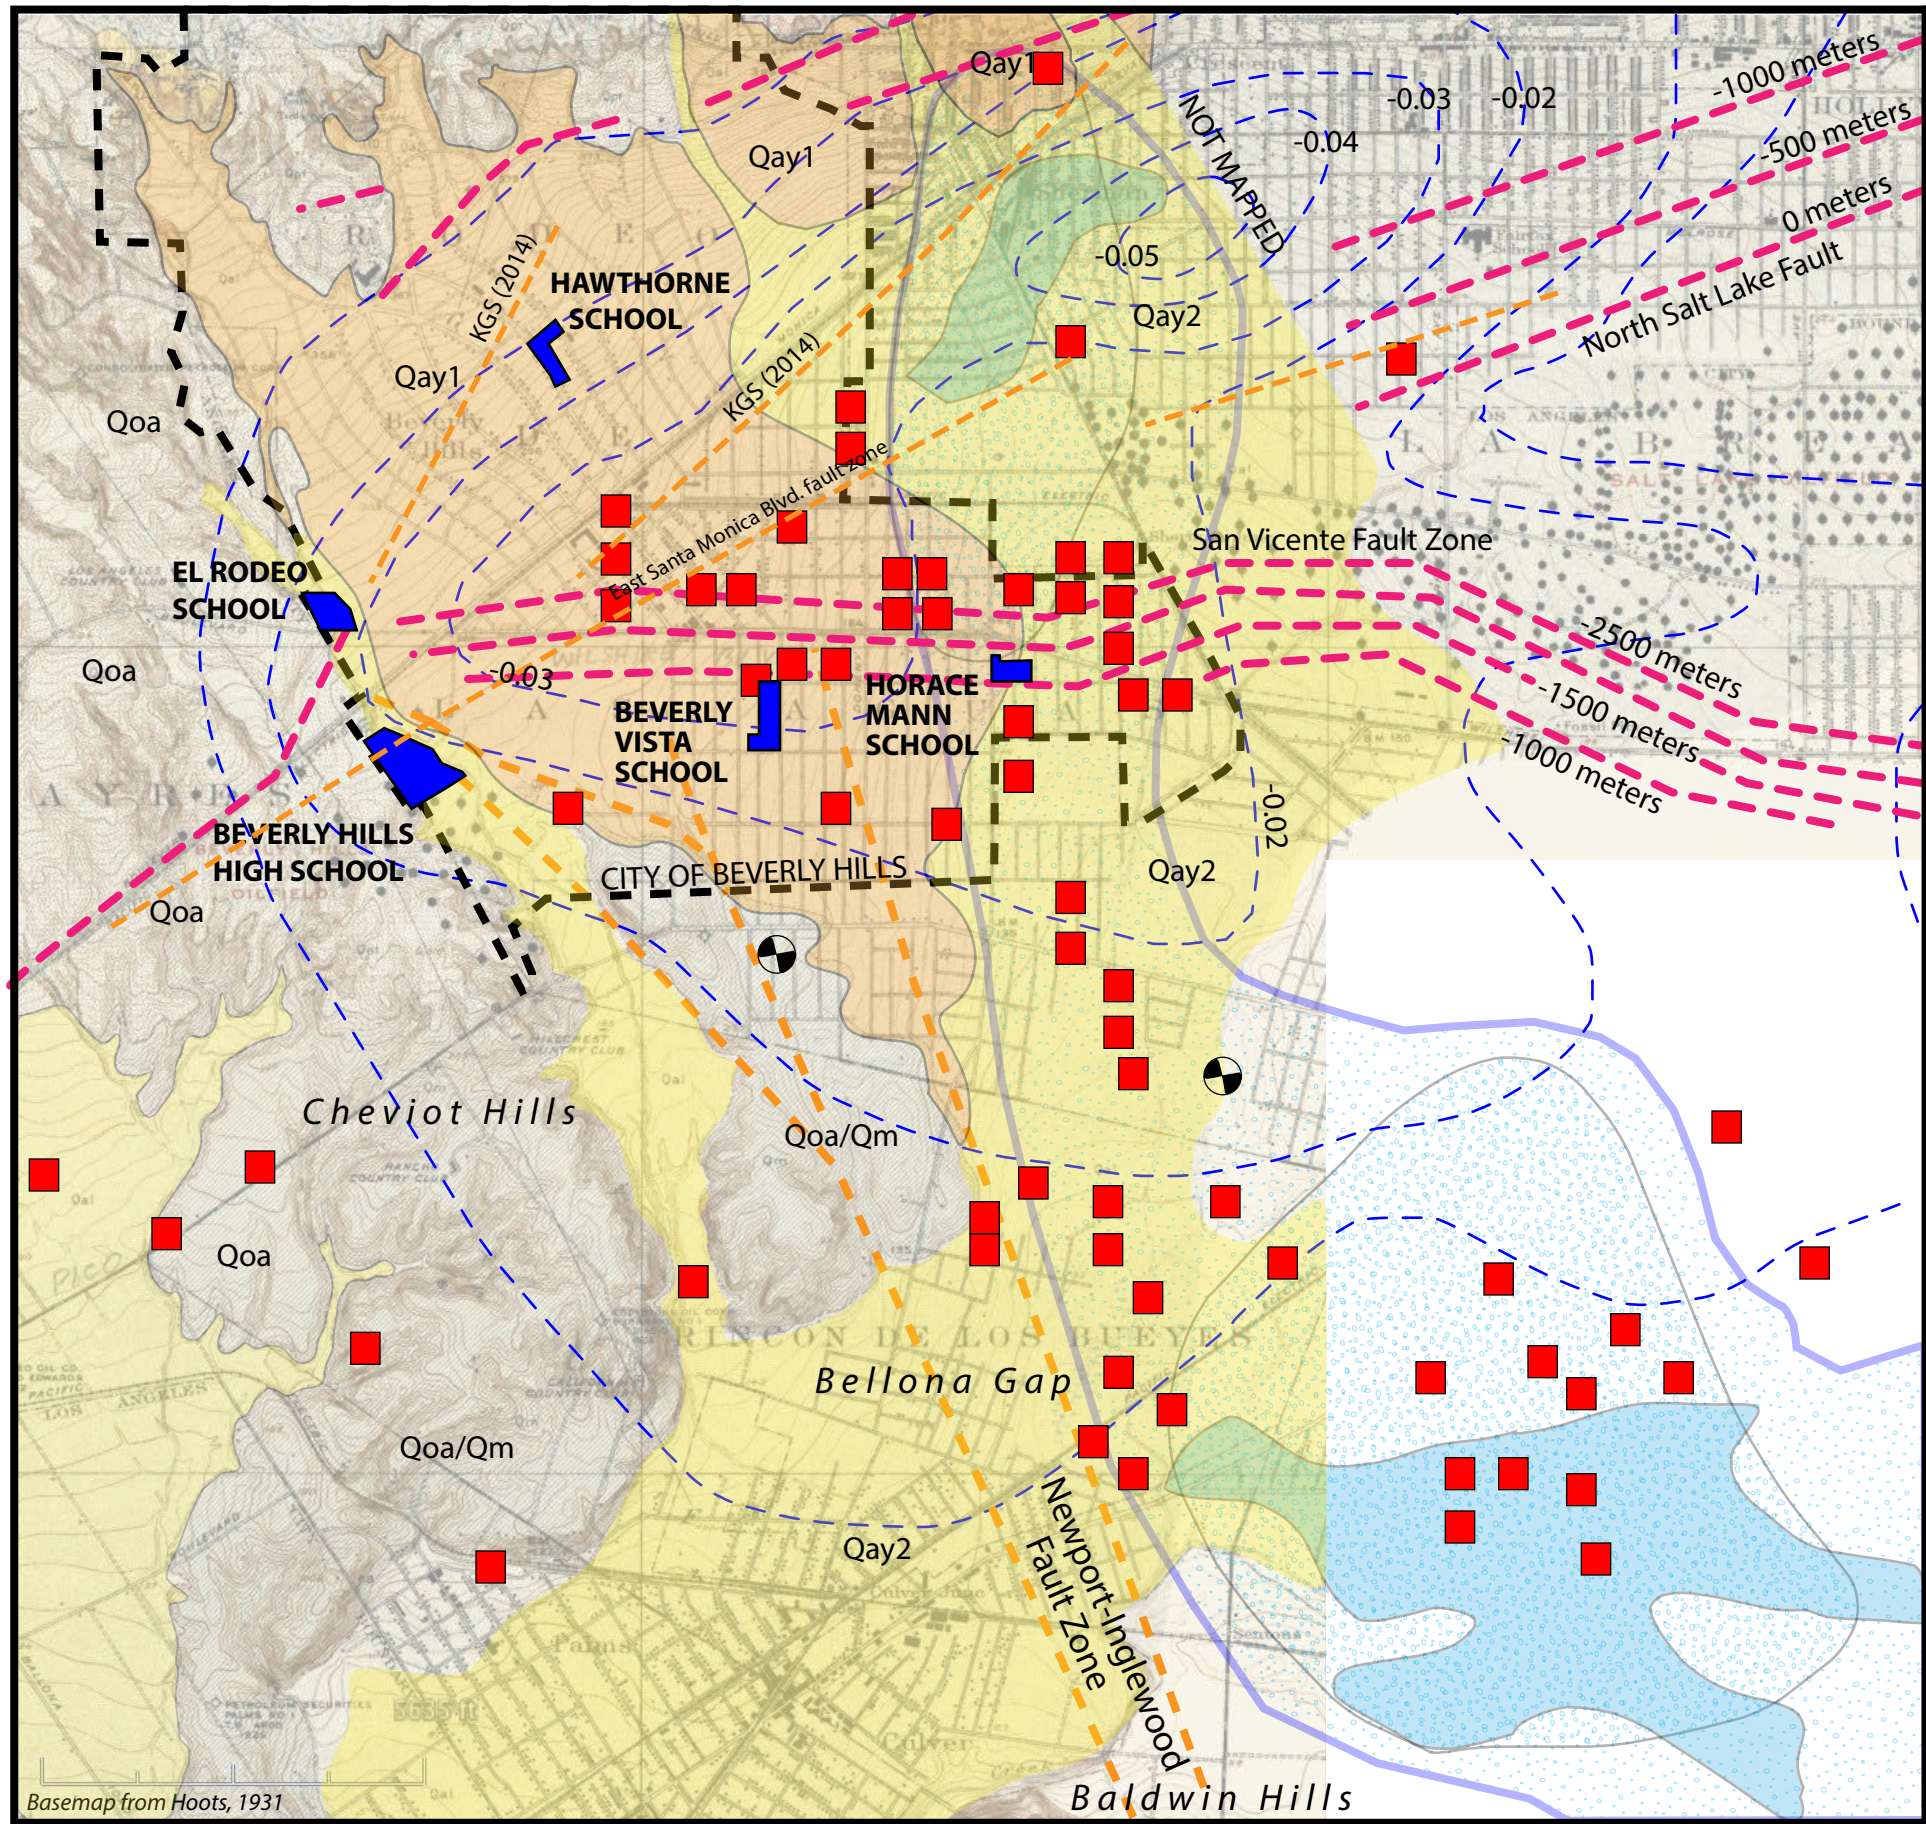
JN 723-11  
Date: JUNE, 2014  
Drafted by: MDK  
**PLATE 2**

The Beverly Vista and Horace Mann schools are located within a zone of red-flagged structures identified after the 1994 Northridge Earthquake (Plate 2). The Beverly Vista school resides along the western edge of the red-flagged structures area and the Horace Mann school resides near the center. The El Rodeo, Hawthorne and Beverly Hills High schools do not reside in the zone of red-flagged buildings (Plate 1).
